Otterton Footpath and Rights of Way Signs - May 2019 Update

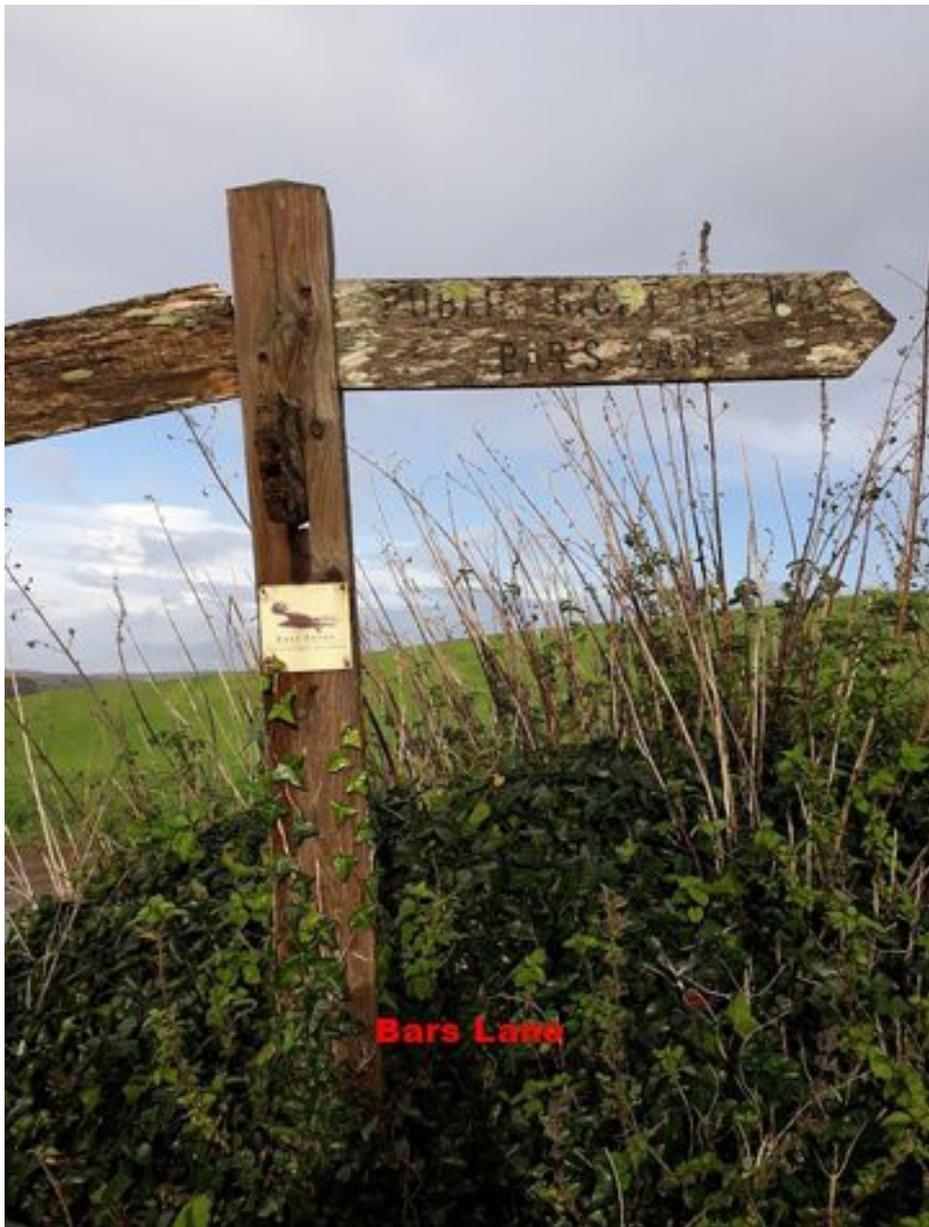
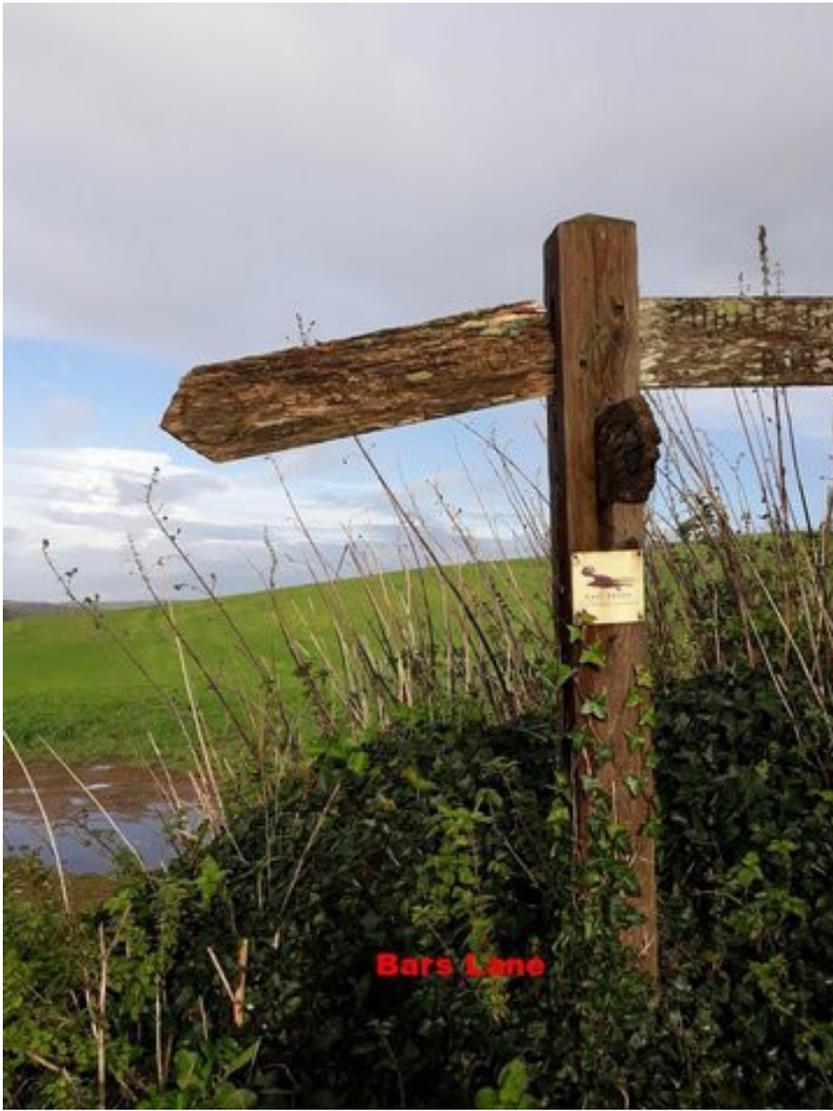
Bar's Lane (308) details

post with 3 arms (see below) | One of 3 arms fallen off (by Seaview Farm), post leaning. Purchase new finger post with 3 arms (see below) | FP1 |

- Three arms (one currently missing)
- NE arm is 600mm long and says "PUBLIC RIGHT OR WAY, BAR'S LANE" OVER 2 LINES, this only needs to be on RHS looking away from post.
- SW arm (now missing) says "OTTERTON" , this only needed on LHS
- SE arm only has a circle at present - I suggest we have "LADRAM BAY" over 2 lines to keep it as short as possible away from traffic.
- 2 Photos below refer
